AVIATION OCCURRENCE REPORT

ARROW AIR INC.

DOUGLAS DC-8-63 N950JW

REPORT NUMBER 85-H50902

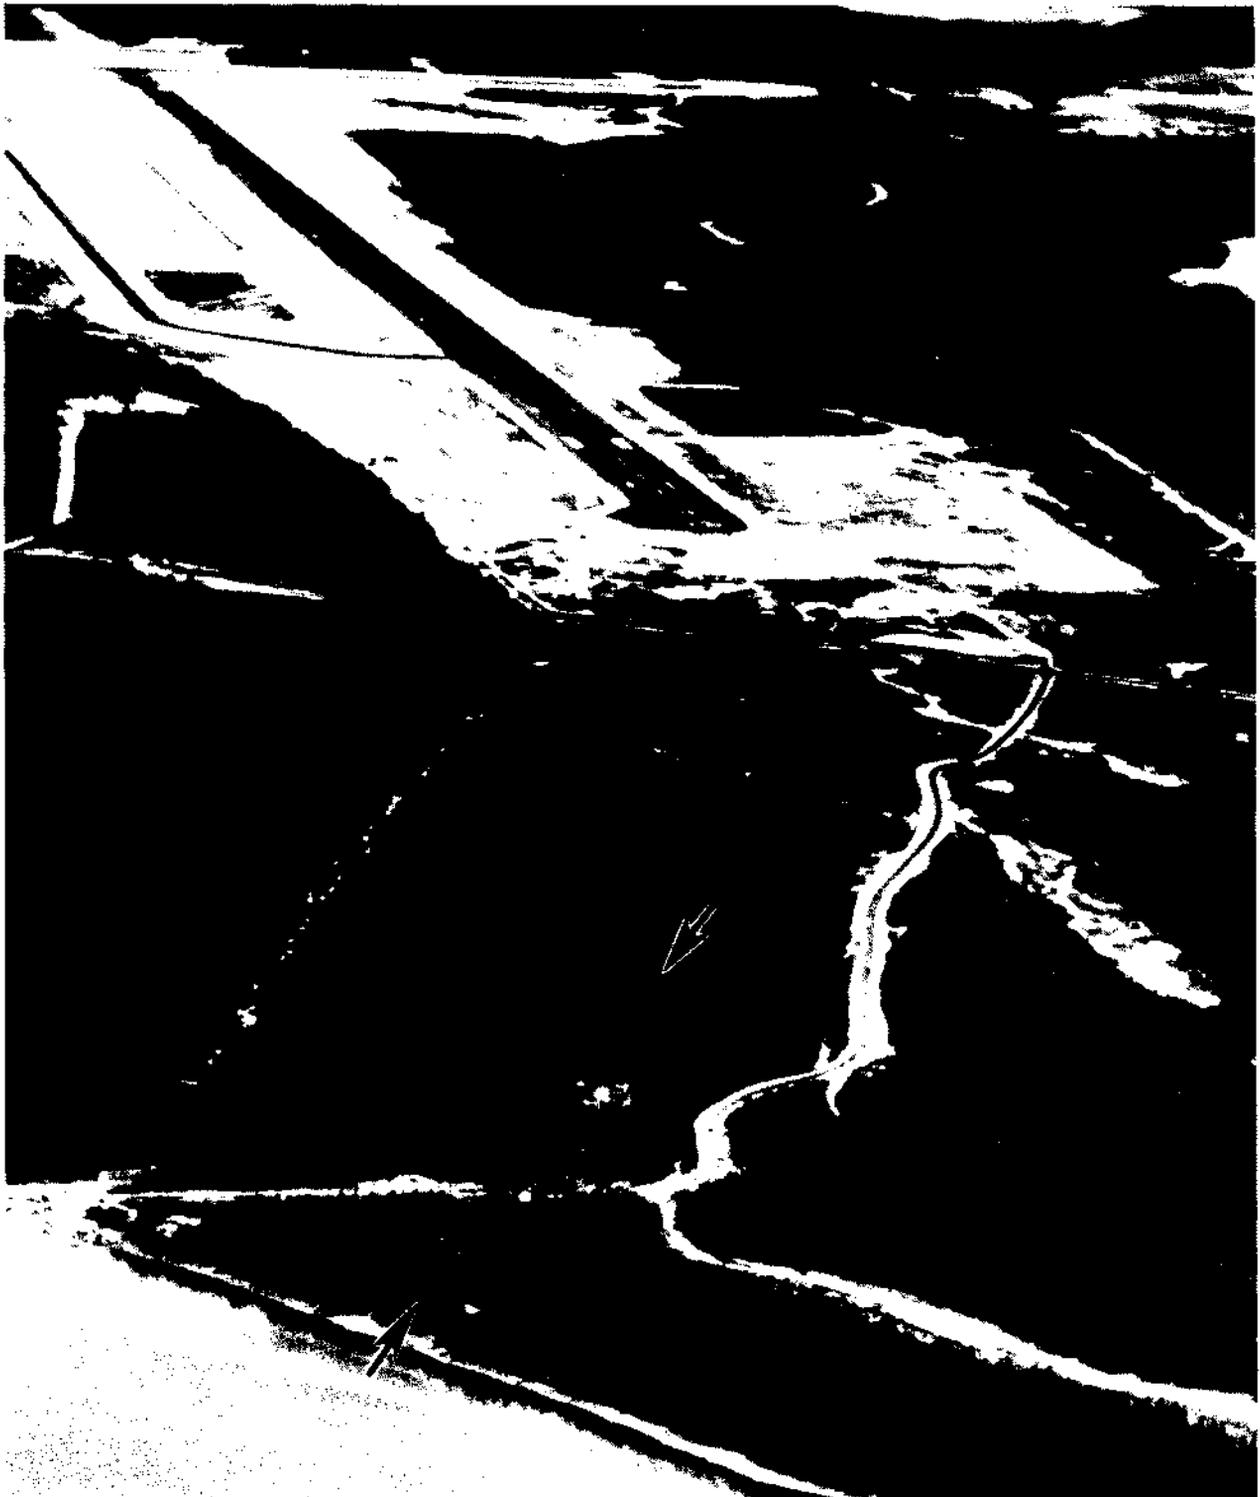
Figure 1.1. Oblique Air Photo of Accident Site

The accident occurred at 1016 during the hours of darkness at lat 48°54'40"N, long 54°34'35"W* at an elevation of 279 feet above sea level (asl).

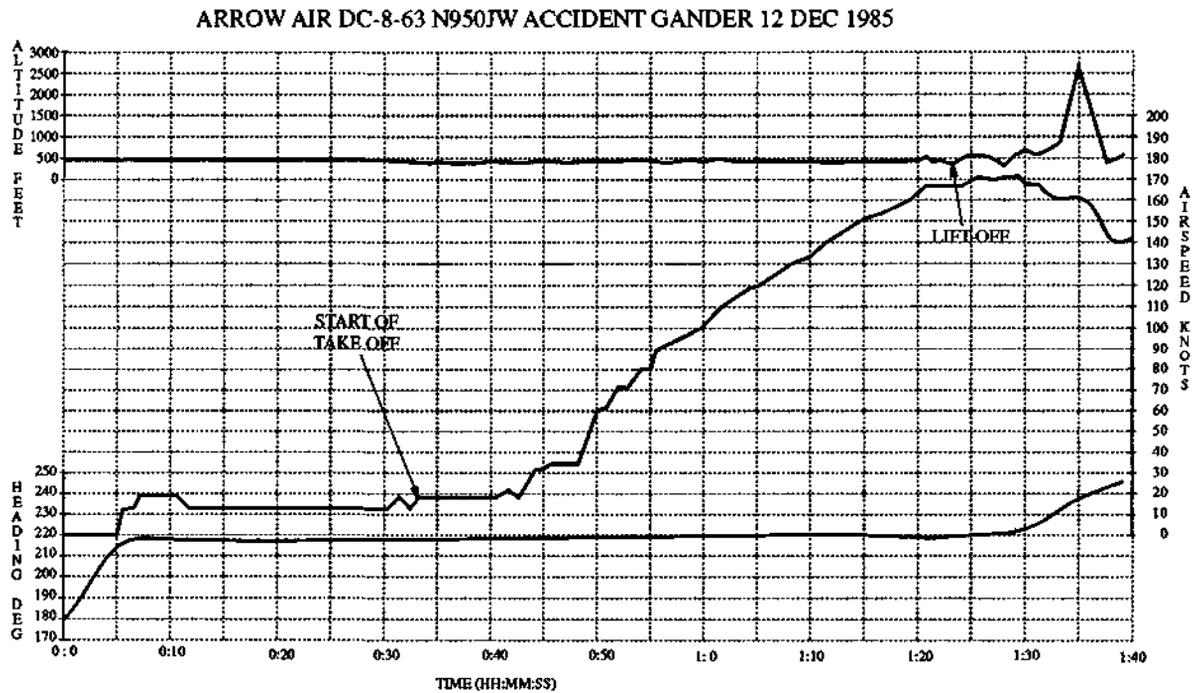
Figure 1.4. FDR Information for Accident Flight

Analysis of the recorded data indicated that the take-off roll commenced at 1015:06. Thereafter, airspeed increased steadily to a peak value of 172 KIAS 53 seconds after commencement of the take-off roll, and then decreased.

Examination of the vertical acceleration trace determined that lift-off occurred about 51 seconds after the commencement of the take-off roll.

The aircraft heading began to deviate to the right at about the time the peak airspeed was achieved. The heading continued to deviate to 25 degrees right of the runway heading before the FDR ceased operation.

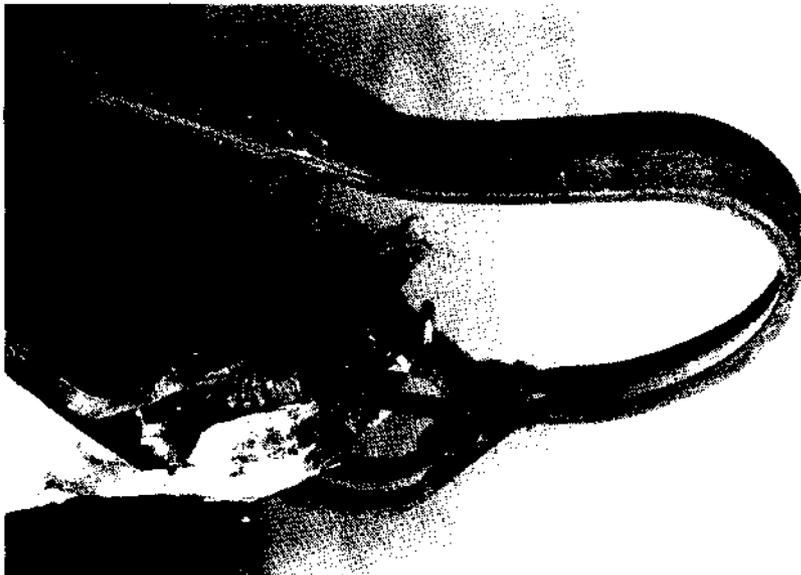
Figure 1.11. Number Four Thrust Reverser Lower Track

THRUST REVERSER NO. 4
LOWER TRACK. AFT END OF
TRACK IS AT TOP IN
PHOTOGRAPH.

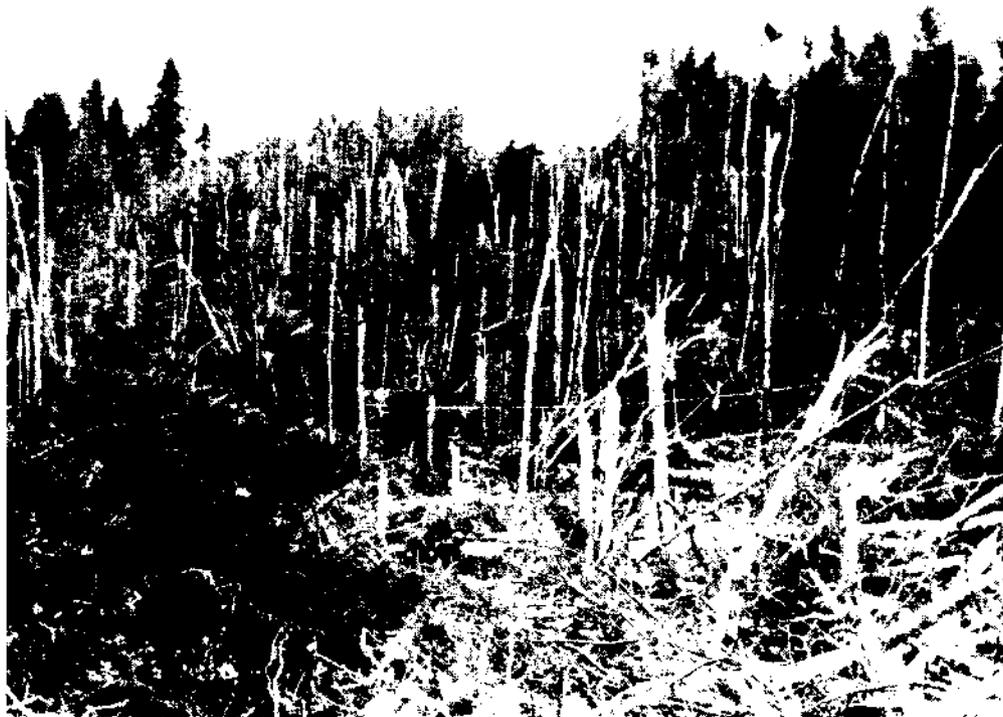
Figure 1.13. Photo of Tree Swath Cut by Aircraft

Using analytical plotters, three dimensional measurements were made of 378 trees which had been cut by the aircraft prior to ground impact (See Figure 1.13.). A 1/100 scale model of the tree-cut zone was then constructed, and a detailed 1/100 scale die cast model of a Douglas DC-8-63 aircraft was mated to the tree pattern (See Figure 1.14.). Flaps were placed on the model at an 18-degree configuration to match post-crash investigation findings. By accurately measuring the orientation of the aircraft model in the tree pattern at increments along its flight path, the attitude of the aircraft and the flight path angle were determined. Measurements indicated that the aircraft first contacted the tree canopy in a seven-degree right bank, nine-degree pitch (the angle between the longitudinal axis of the fuselage and the horizontal), and a 10-degree yaw right attitude, on a descending, 12-degree flight path angle (the angle between the flight path and the horizontal).

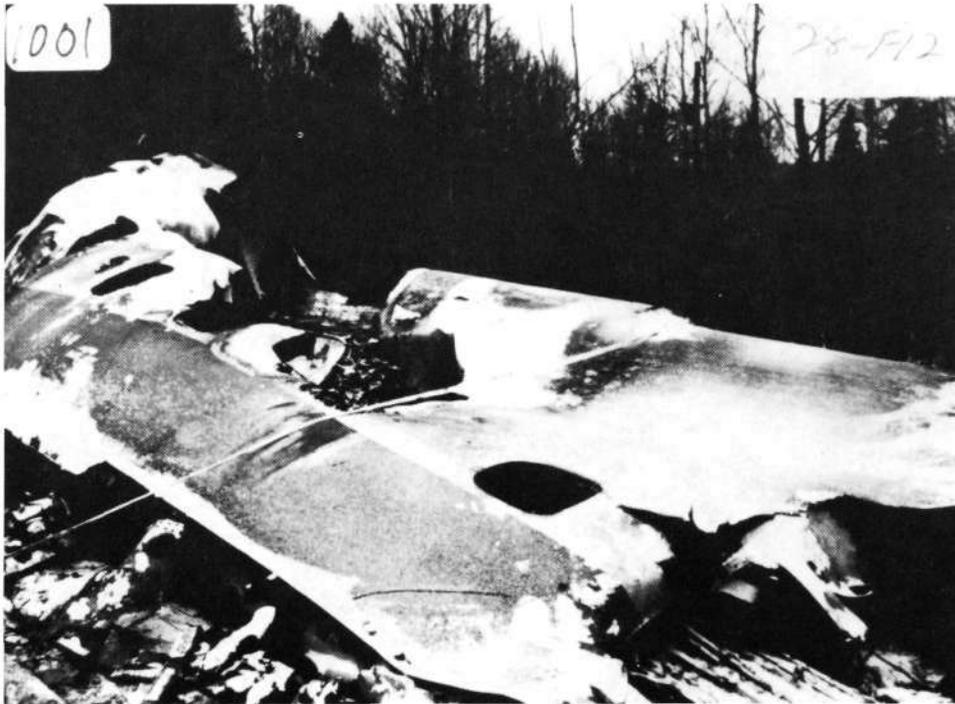
Figure DO4. Fire-damaged fuselage section

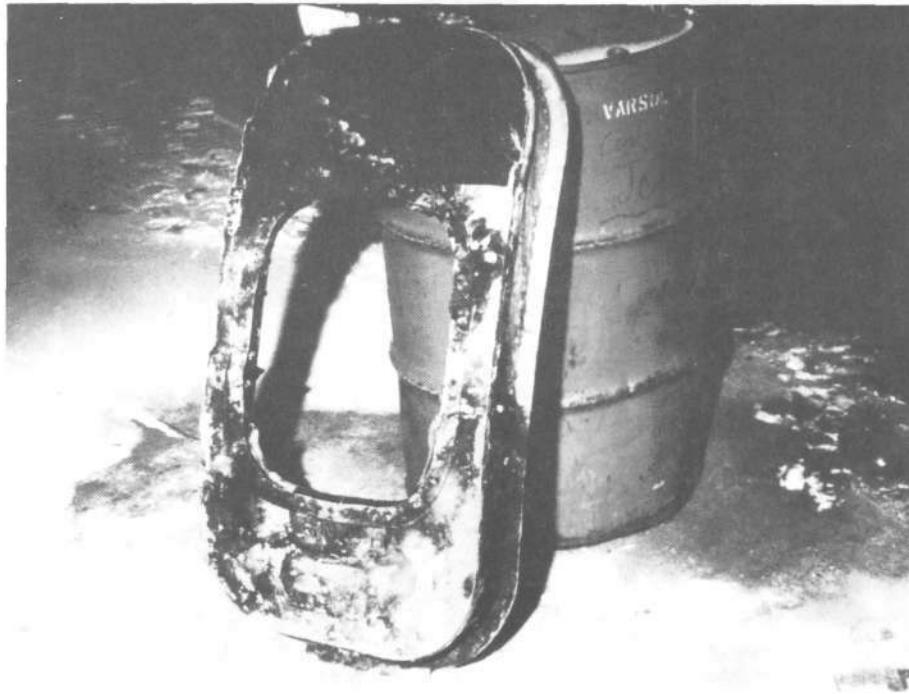
Figure DO5. Emergency exit showing soot deposits around edges

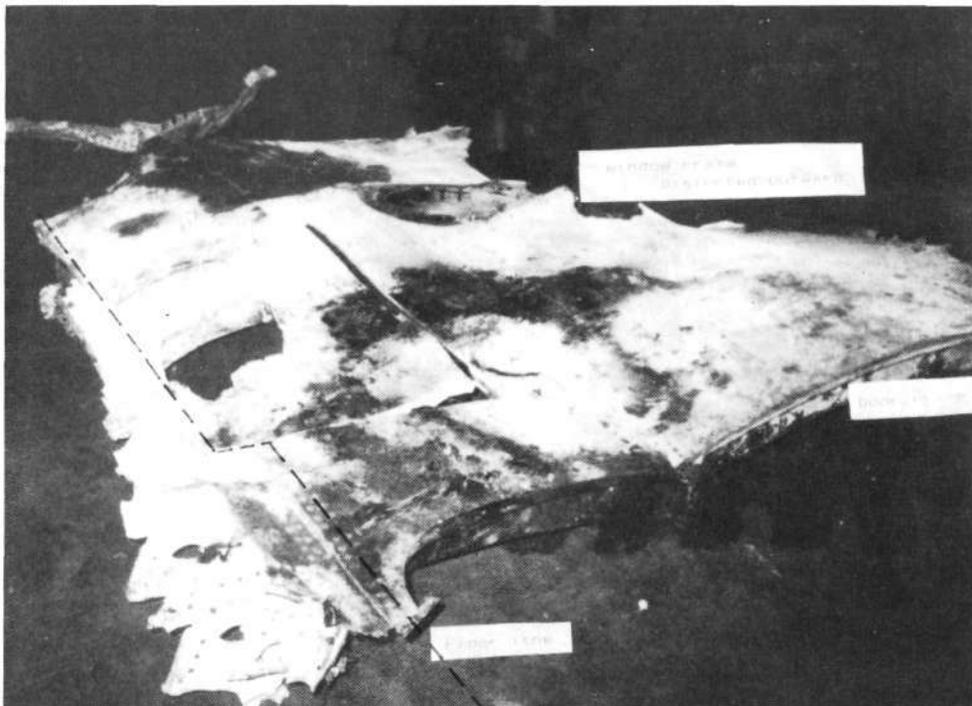
Figure DO10. Explosively punched hole in fuselage panel

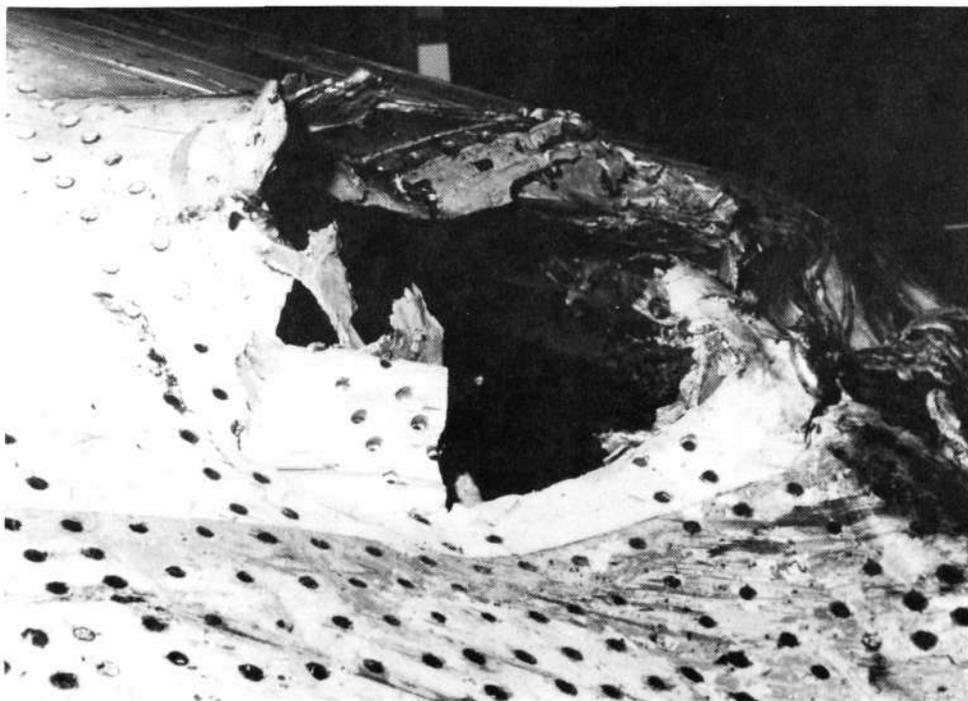
Figure DO11. Hole apparently ripped by explosion

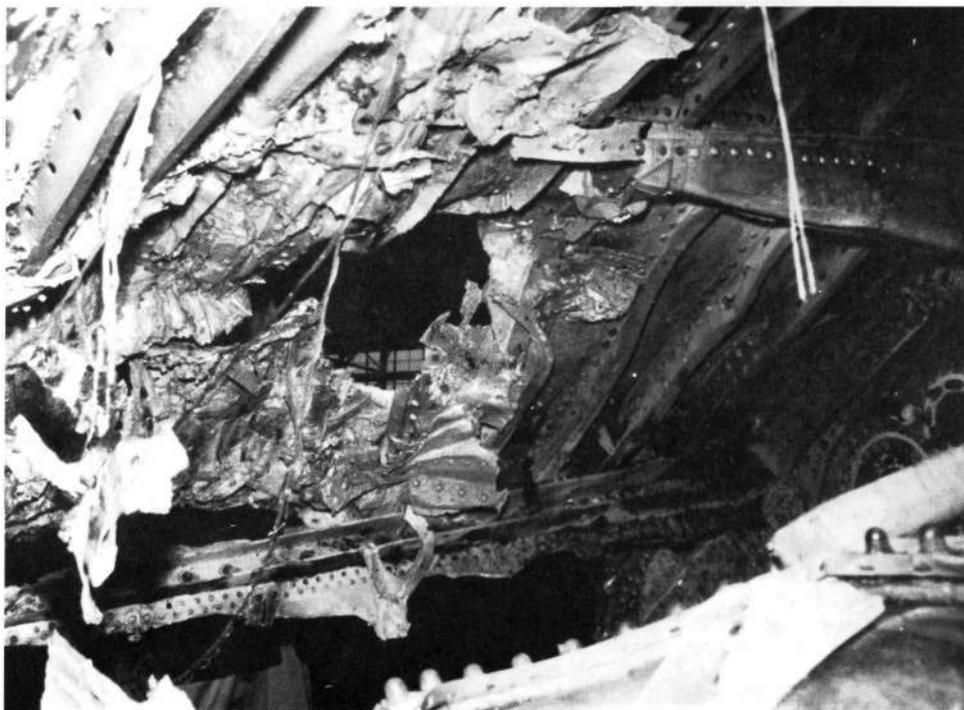
Figure DO12. Interior view showing extensive battering

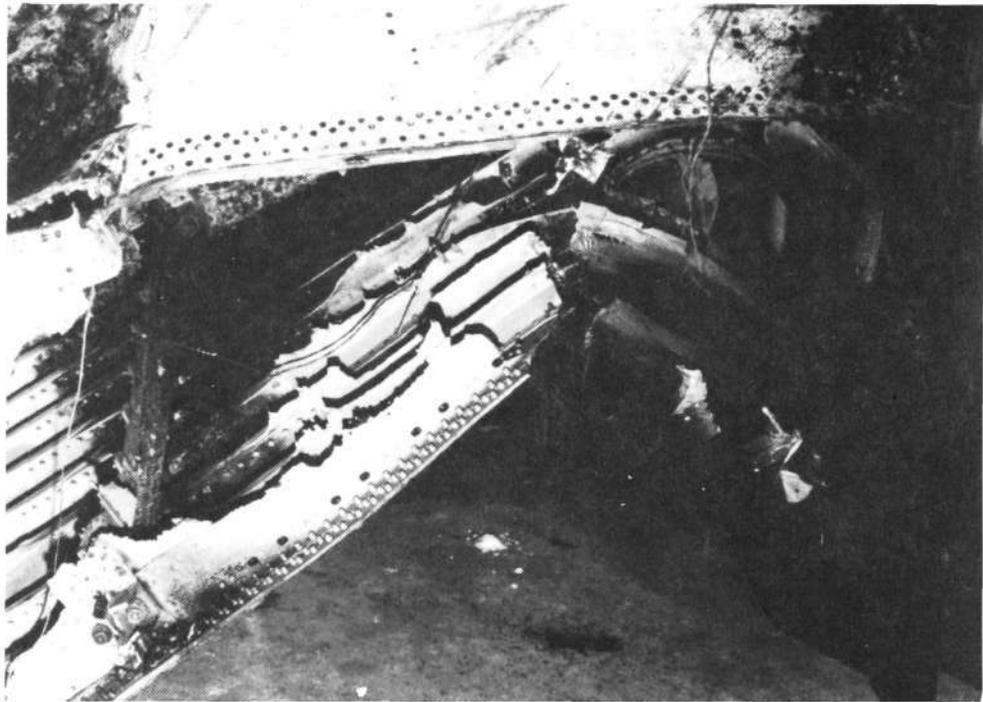
Figure DO13. Possible explosive fracture
