Final Report

5X011-0/98
April 2001

Type of Occurrence:	Serious Incident
Date:	14. Dezember 1998
Location:	15 km westlich Cottbus
Aircraft:	Aircraft
Manufacturer, Model:	Aerospatiale-Alenia/ATR 42-300
Injuries to Persons:	no injuries
Damage:	Aircraft not damaged
Other Damage:	none

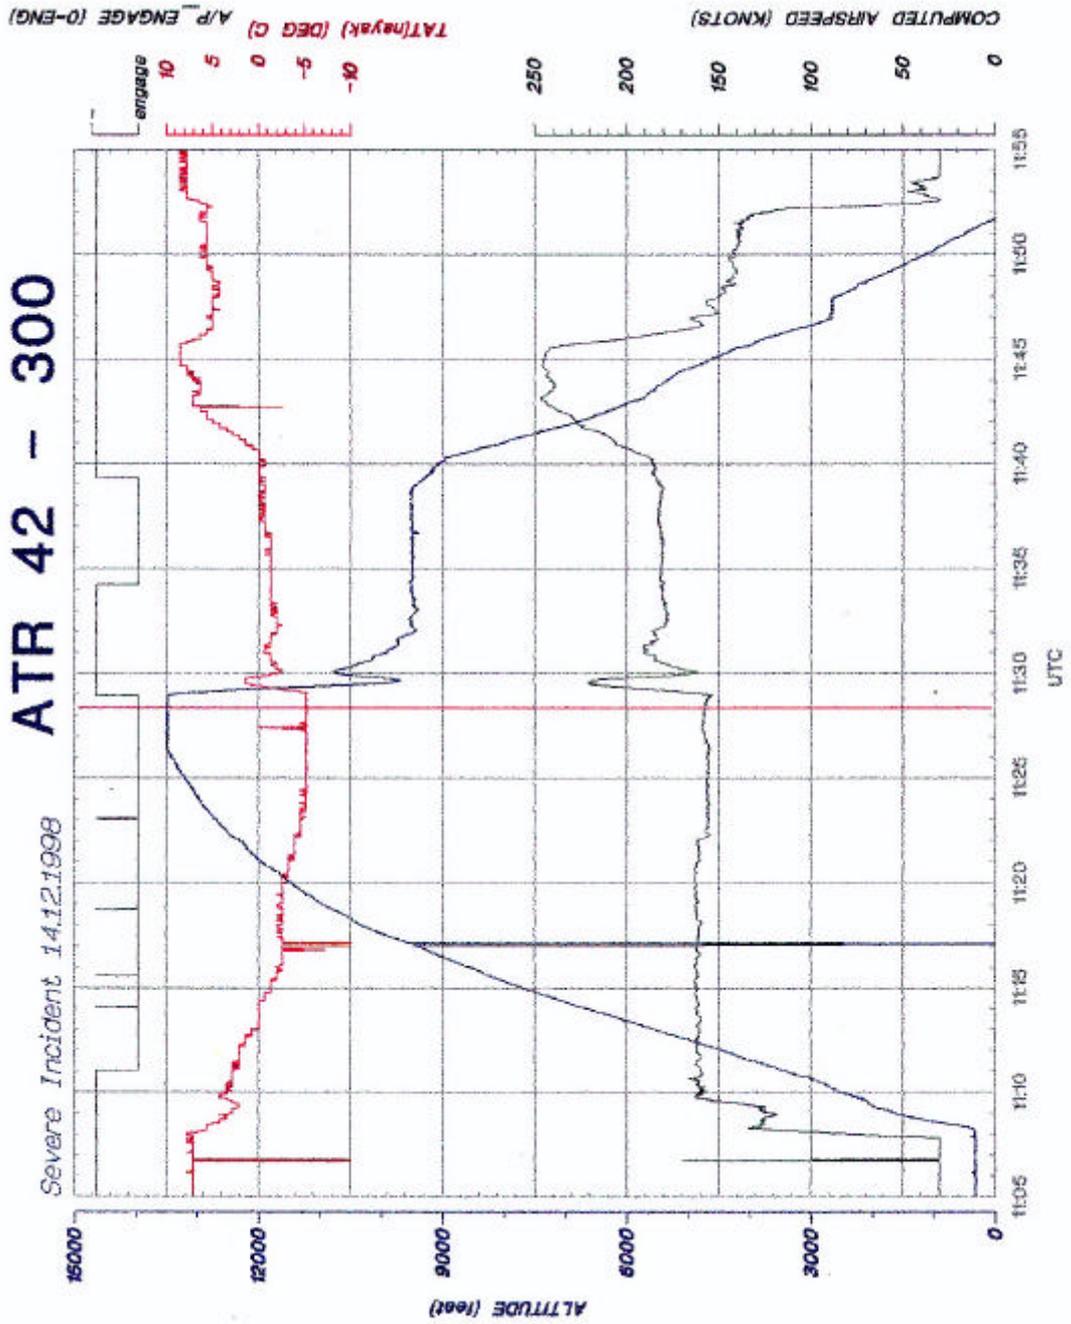
Attachment 2

The evaluation covered the period of time relevant to the incident, from the activation of the ALT HOLD Mode at FL 135 (11:26:20 UTC) until the crew had regained control of the aircraft (11:29:44 UTC(Attachment 2)).

At 11:28:54 UTC after 154 s of flight in the ALT HOLD Mode the AOA-threshold was exceeded so that the stall warning was activated and the AP disconnected. The yaw damper remained in circuit. Immediately the left bank angle increased, the pitch decreased and the aircraft assumed an uncontrolled flight attitude.

- High bank angles changing from left to right counteracted by opposite aileron deflections by the crew with almost identical frequency with extreme values of 103° to the right and 48° to the left, resulting in the so-called wing rocking.

- Rudder deflections coordinated with aileron deflections.
- The AOA did not decrease considerably during the first 43 s - in the meantime it increased to values up to 15° - only at 11:29:37 UTC AOA values below 10° were recorded.
- The elevator position remained nearly unchanged.
- The trim tab was not operated.
- The pitch decreased to a minimum of -17°.
- The airspeed increased to a maximum value of 221 kt.
- The vertical acceleration reached a maximum of +2.16 g.
- The speeds of the propellers remained constant at 86%.
- After 10 s of uncontrolled flight the crew increased the engine torque to approx. 107%.
- The loss of altitude was approx. 3800 ft.
- At approx. FL 110 the aircraft reached warmer air masses (TAT up to +1°C).
- The wing rocking stopped when the speed increase reduced the AOA below the critical value.
- There was no other conflicting air traffic.
