AIRCRAFT ACCIDENT REPORT

ADOPTED March 8, 1965

FRONTIER AIRLINES, INC.
DOUGLAS DC-3C, N61142
MILES CITY, MONTANA
MARCH 12, 1964

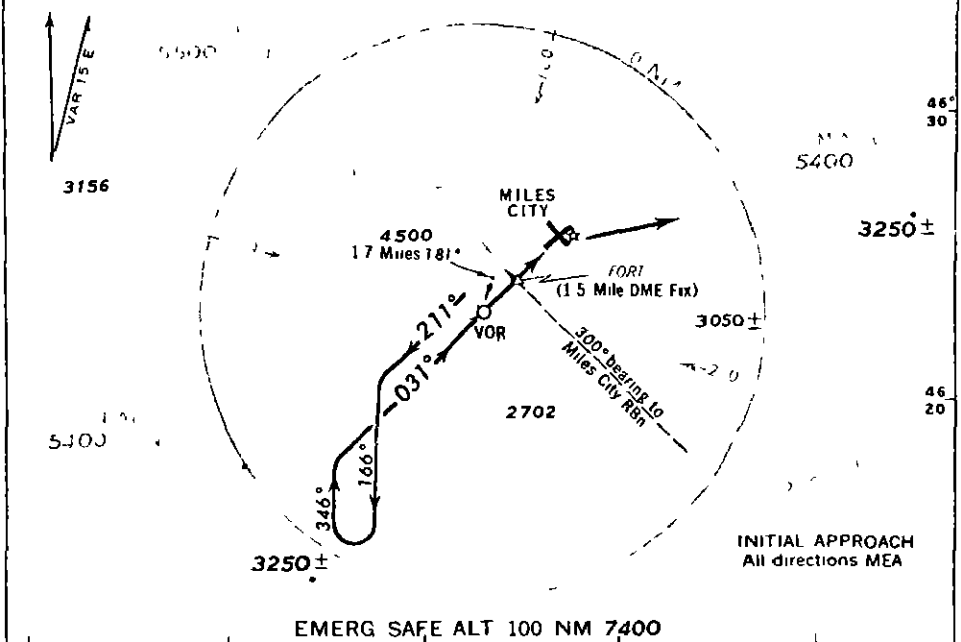
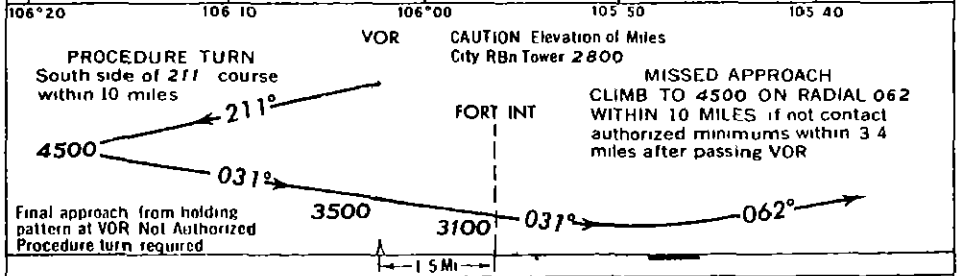
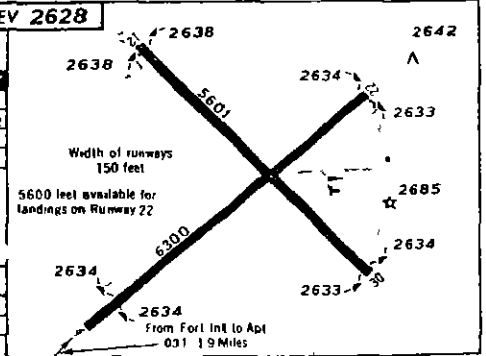
Attachment "A"
Frontier Airlines, Inc.
DC-3 N6144Z
Miles City, Mont. 3/12/64

^{4/} There are four FAA-approved public instrument approach procedures applicable to the MLS Airport. These are a VOR, an ADF and two VOR/DME approaches. Only the VOR or the ADF approaches could have been utilized by Flight 32 as it was not equipped with DME (Distance Measuring Equipment). (See Attachment "A".)

The VOR approach procedure prescribes that the aircraft starts a descent from an altitude not below the minimum en route altitude (6,000 feet) to 4,500 feet outbound on the 211-degree radial of the VOR and executes a procedure turn not below that altitude. Upon completion of the procedure turn further descent to 3,500 feet is authorized while inbound to the station on a 031-degree course. After crossing the VOR on final approach, descent to 3,100 feet is authorized until passing Fort Intersection (a 300-degree bearing from the MLS radio beacon). Further descent to minimum altitude is then authorized. The night weather minima for this approach (circling)^{13/} were ceiling 400 feet and visibility one mile for any runway. The procedure as depicted on both the U.S. Coast and Geodetic and Jeppesen approach charts provides that final approach is not authorized from the holding pattern at the VOR and that a procedure turn must be made.
