R e p o r t

Cessna 560 on January 2, 1996

at Augsburg

File no. : C X 001-0/96

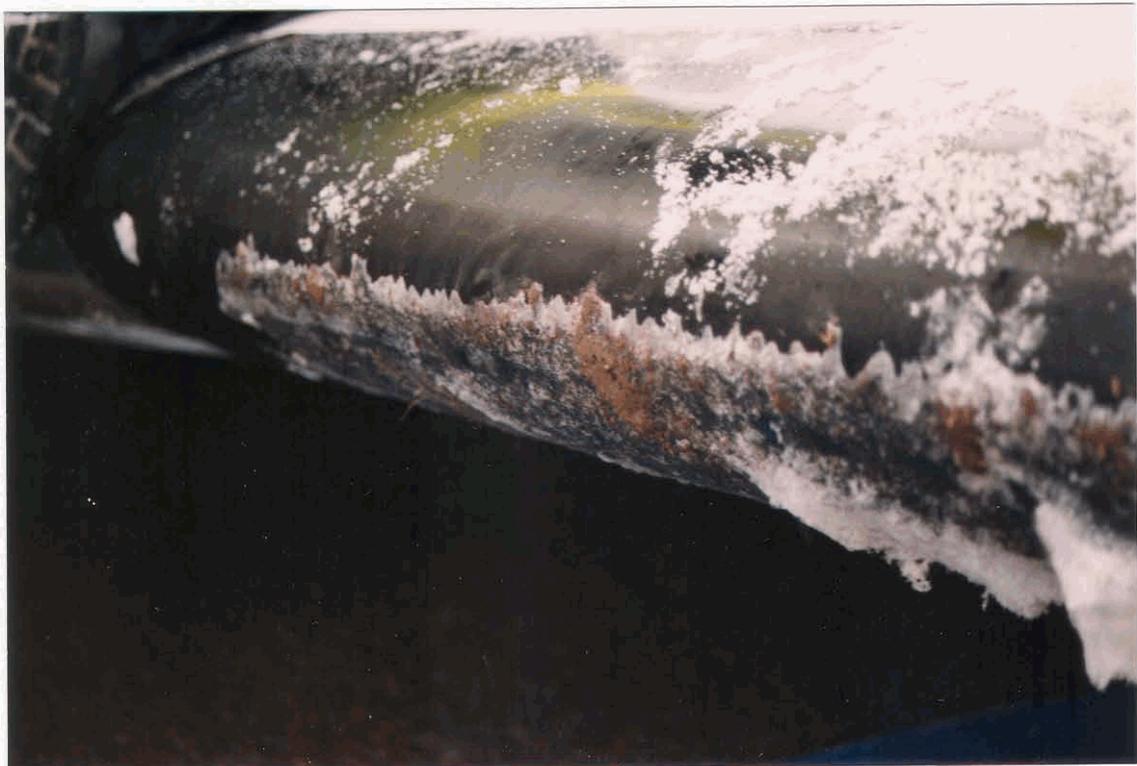
When preserving traces at the accident site, the members of the FUS found both wings showing ice accretion approximately 2 mm thick, progressing from the wing leading edge approximately 30 cm towards the lower surface (Appendix 1).

- *The pilots held the licences and ratings applicable for the flight.*
- *The aeroplane was registered at the Bermuda Islands and properly approved for the flight.*
- *Technical deficiencies were not discovered, mass and balance were within the limitations.*
- *The weather corresponded to the meteorological forecast; icing conditions prevailed.*
- *Approach was carried out manually upon reaching visual contact.*
- *At a height of approximately 50 m, the aeroplane stalled unexpectedly first over the right, then over the left wing and touched the ground.*
- *After approximately 230 m, the aeroplane came to a stop on the shoulder between runway and taxiway „F“.*
- *Slight ice accretion with a thickness of approximately 2 mm was discovered at the wing.*

Ice accumulation at the lower surface of the leading edge
