AVIATION OCCURRENCE REPORT

ARROW AIR INC.

DOUGLAS DC-8-63 N950JW

REPORT NUMBER 85-H50902

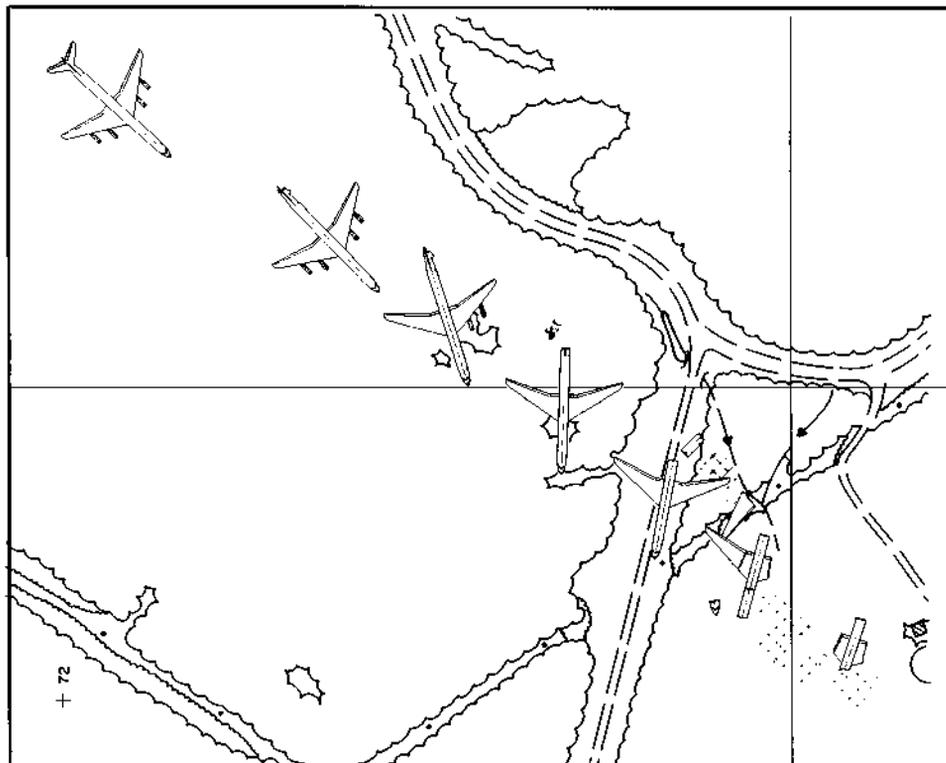
Figure 1.6. Aircraft Breakup Sequence

A thorough search of the runway and the area between the runway end and initial impact point was conducted with the assistance of personnel from Canadian Forces Base Gander. No components or debris was located that could have come from the aircraft. There was no evidence that the aircraft tail had touched the runway during the take-off. (See Figure 1.6.)

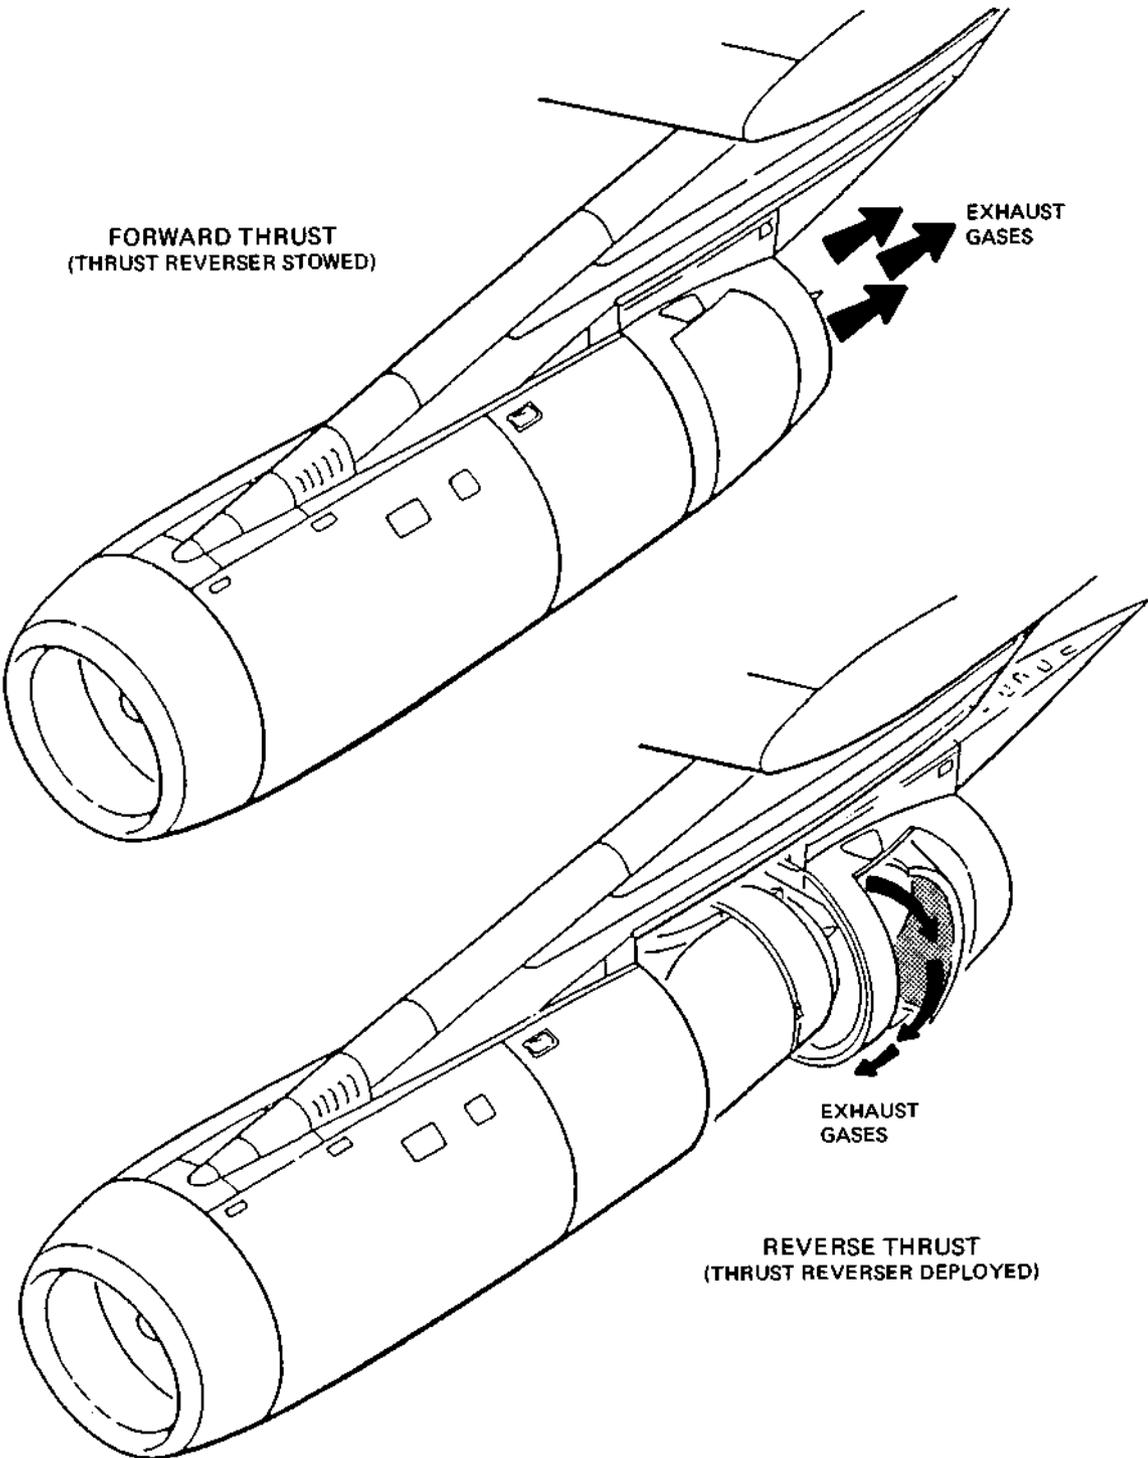
Figure 1.7. Schematic of Thrust Reverser Assembly

The deployment of the thrust reversers involves two actions: the rearward movement of the translating ring with the deflector doors in the faired position; and a final rearward movement of the translating ring (approximately seven inches) during which the stop on the latch rod contacts and operates an actuating mechanism, causing the deflector doors to open. The deflector doors can only be in the deployed position if the translating ring is in the full-aft position. (See Figure 1.7.)

The number four reverser assembly had separated from the exhaust nozzle at impact. The forward loop of the translating ring assembly was broken with pieces missing from both sides. The lower deck was twisted 180 degrees around the rear section of the ring so that the forward face of the upper part of the translating ring was at one end of the assembly and the forward face of the lower portion was at the other end. The outboard deflector door was trapped by the structure in the faired position at the lower hinge point. The metal skin in this area was deformed inward, trapping the actuating arm in the faired position. The upper actuating arm for this door was torn away from the translating ring, but there were clear witness marks on the slot edge showing that the arm was in the faired position at the time this damage occurred (Figure 1.8.). The inboard deflector door was torn away from the upper attachment point and was twisted to the deployed position. There was moderate to heavy damage to the forward edge of this door. There were deformed areas to the aft end of the actuating arm slots at both the upper and lower hinge points, evidence that the actuating arms for the inboard deflector door were also in the faired position at impact (Figure 1.9. and Figure 1.10.). The lower track was severely twisted but remained attached by the slide bracket to the forward edge of the translating ring. The slide was within 12.5 inches of the forward position and could not have slid forward after this impact deformation had occurred (Figure 1.11.). The hydraulic actuator was near the forward end of the piston rod. The outer cylinder had split lengthwise, with the material around the split bowed out (Figure 1.12.). This evidence was consistent with rapid extension of the actuator by external forces, and further confirmed that the translating ring had been in the forward position at the time of ground impact. It was concluded that the number four reverser was in the faired position with the translating ring in the forward (stowed) position at ground impact.

No failures were noted in any of the four reverser systems other than those resulting from impact.

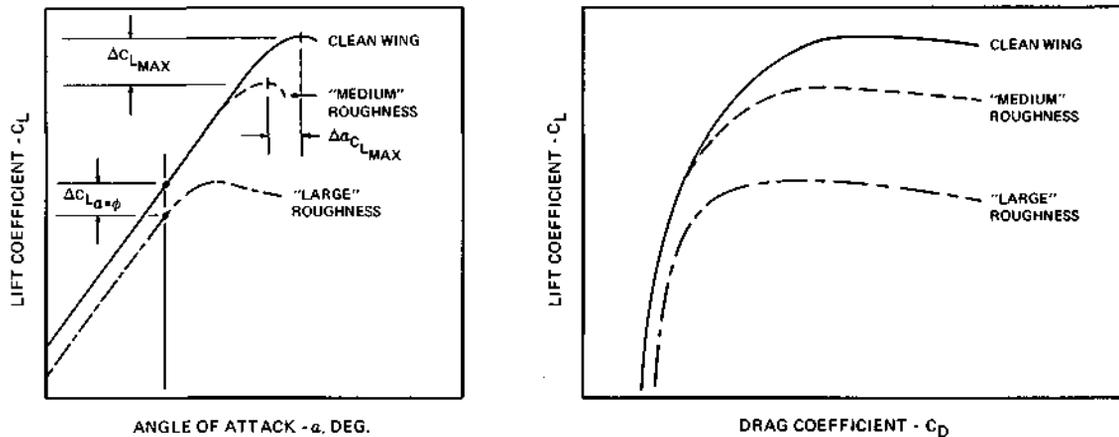
Figure 1.15. Typical Effect of Surface Roughness at the Leading Edge on Aerodynamic Characteristics

Considerable research has been conducted into the effects of ice contamination on airfoil performance. As a result of this research, it is accepted that, in general, ice accretion on the leading edge or upper surface of an aircraft wing results in an increase in stalling speed, decrease in the stall angle of attack, and rapid drag increase near the stall. (See Figure 1.15.)

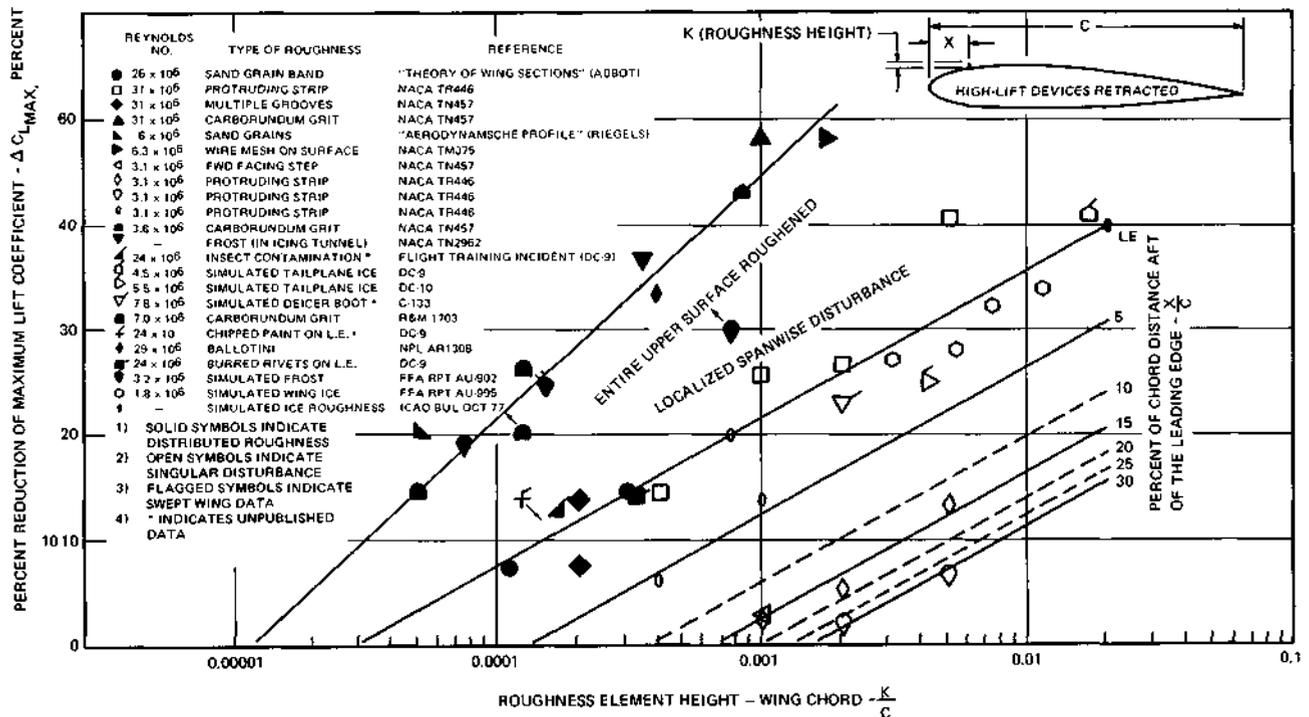
Figure 1.16. Reduction of Maximum Lift Coefficient Due to Wing Surface Roughness

tal effect equivalent to that caused by some lesser degree of roughness elements distributed over the entire surface of the wing. The relative effects of such localized ridges, grooves, or narrow bands of roughness as a function of the location of the roughness expressed in percentage of chord can be seen in Figure 1.16.

Data provided by Douglas Aircraft enabled the Board to estimate the decrease in coefficient of lift maximum which would result from the calculated leading edge accretion amounts. As seen in Figure 1.16., the per cent reduction of maximum lift coefficient which results from a localized, spanwise disturbance or narrow band of roughness located at the leading edge is a function of the roughness height divided by chord length.

From Figure 1.16. it can be seen that the reduction of maximum lift coefficient determined at the 85, 53, and 26 per cent semi-spans equates to full upper surface contamination with roughness elements of 0.052 inches, 0.033 inches, and 0.022 inches respectively.

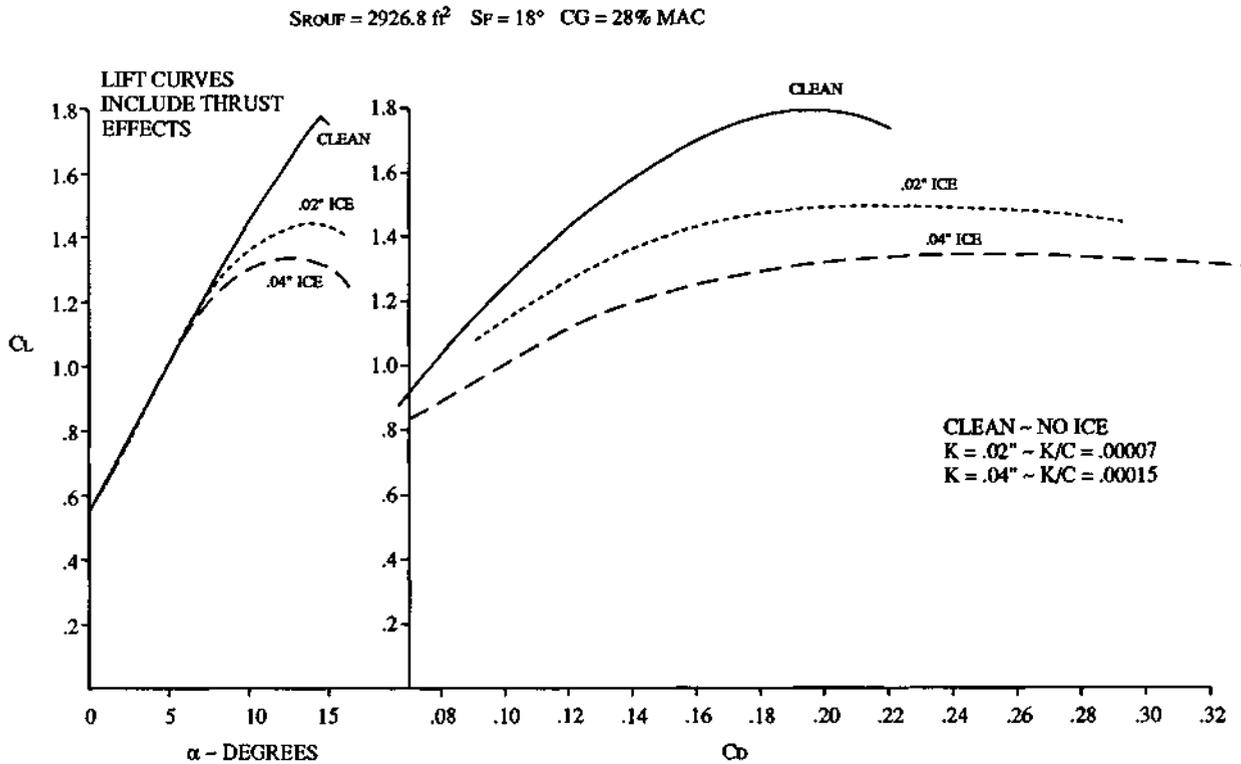
Figure 1.17. Model DC-8-63 Effect of Wing Upper Surface Distributed Roughness on Aircraft Lift and Drag

The lift penalty which results from closed wing slot doors is a 0.2 reduction in maximum coefficient of lift. Ground spoiler deployment results in a 0.4 reduction in coefficient of lift at zero degrees angle of attack. This reduction increases as angle of attack increases. Douglas Aircraft Co. was unable to provide exact data for higher angles of attack. With respect to ice contamination, Douglas Aircraft Co. supplied information which indicated that, with wings contaminated by surface roughness elements of 0.04 inches, maximum coefficient of lift would be reduced by about 25 per cent. The coefficient of drag at or beyond the stall angle of attack (which would be a lower than normal angle) would increase by greater than 100 per cent relative to an uncontaminated wing operating at the same angle of attack, below the stall. (See Figure 1.17.)

Unlike the Boeing 737, the Douglas DC-8-63 is not equipped with wing leading edge devices. Douglas Aircraft Co. confirmed that the performance degradation experienced by the DC-8-63 with small amounts of contamination is significantly greater than that encountered by other aircraft types equipped with leading edge devices. Information provided by the Douglas Aircraft Co. indicated that significant reduction in the maximum coefficient of lift and significant increase in the coefficient of drag would be experienced with surface roughness elements of 0.04 inches. (See Figure 1.17.)

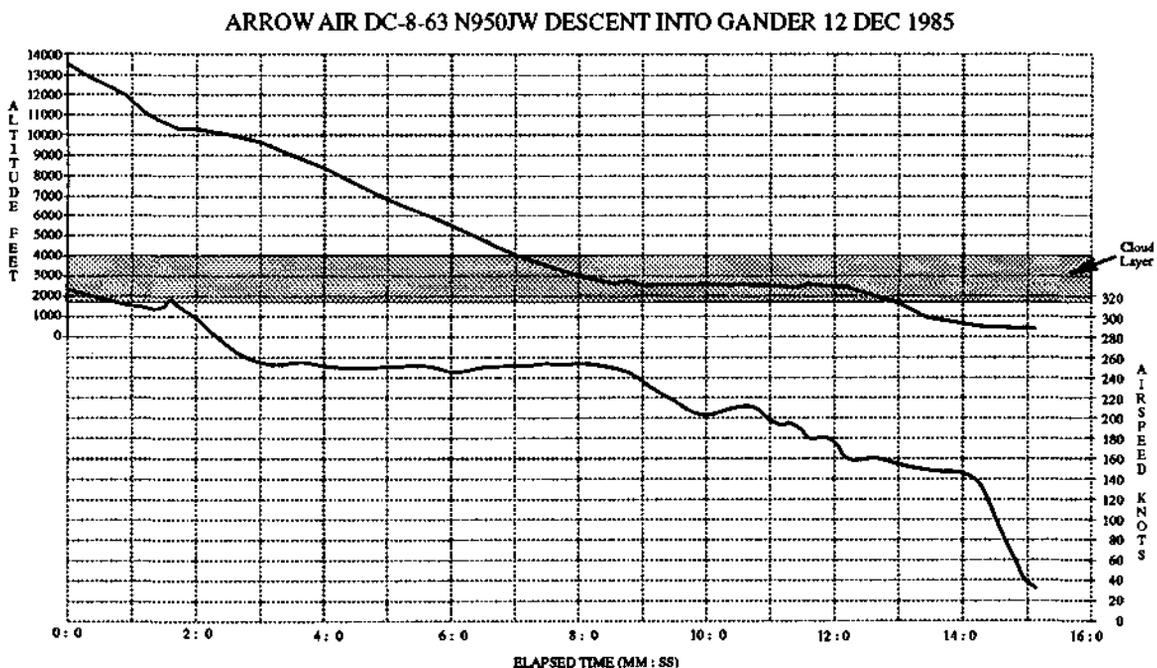
Figure 1.18. FDR Plot of Approach to Gander

One calculation used a method described in the *United States Federal Aviation Agency Technical Report: "Engineering Summary of Airframe Icing Technical Data."* This calculation resulted in a predicted ice accretion on approach of about 0.25 inch on the outboard portion of the wing.
